<div><div>LaCroix</div><div>Davis</div><div>LLC</div><div><small>Building the foundation for the future</small></div></div></div>		
REVISIONS		
NO.	DATE	NOTES
	11/23/08	DRAFT
	12/14/08	FIELD EDITS
	12/17/08	FIELD EDITS
	2/3/09	FIELD EDITS
	2/11/09	FIELD EDITS
	2/21/09	FINAL EDITS
	2/25/09	FINAL EDITS
CLIENT		
STATE OF CALIFORNIA DEPARTMENT OF GENERAL SERVICES (DGS NO. 125828) (AGMT. NO. 3126150)		
PROJECT LOCATION		
BOARD OF EQUALIZATION BUILDING 450 N STREET SACRAMENTO, CA. 95814		
PROJECT		
STATE OF CALIFORNIA, DGS BOE ASSESSMENT (LCD NO. 2372-572)		
DESCRIPTION		
WATER DAMAGE SURVEY		
LOCATION		
14TH FLOOR		
SHT NO.	SHT NAME	
14	A14

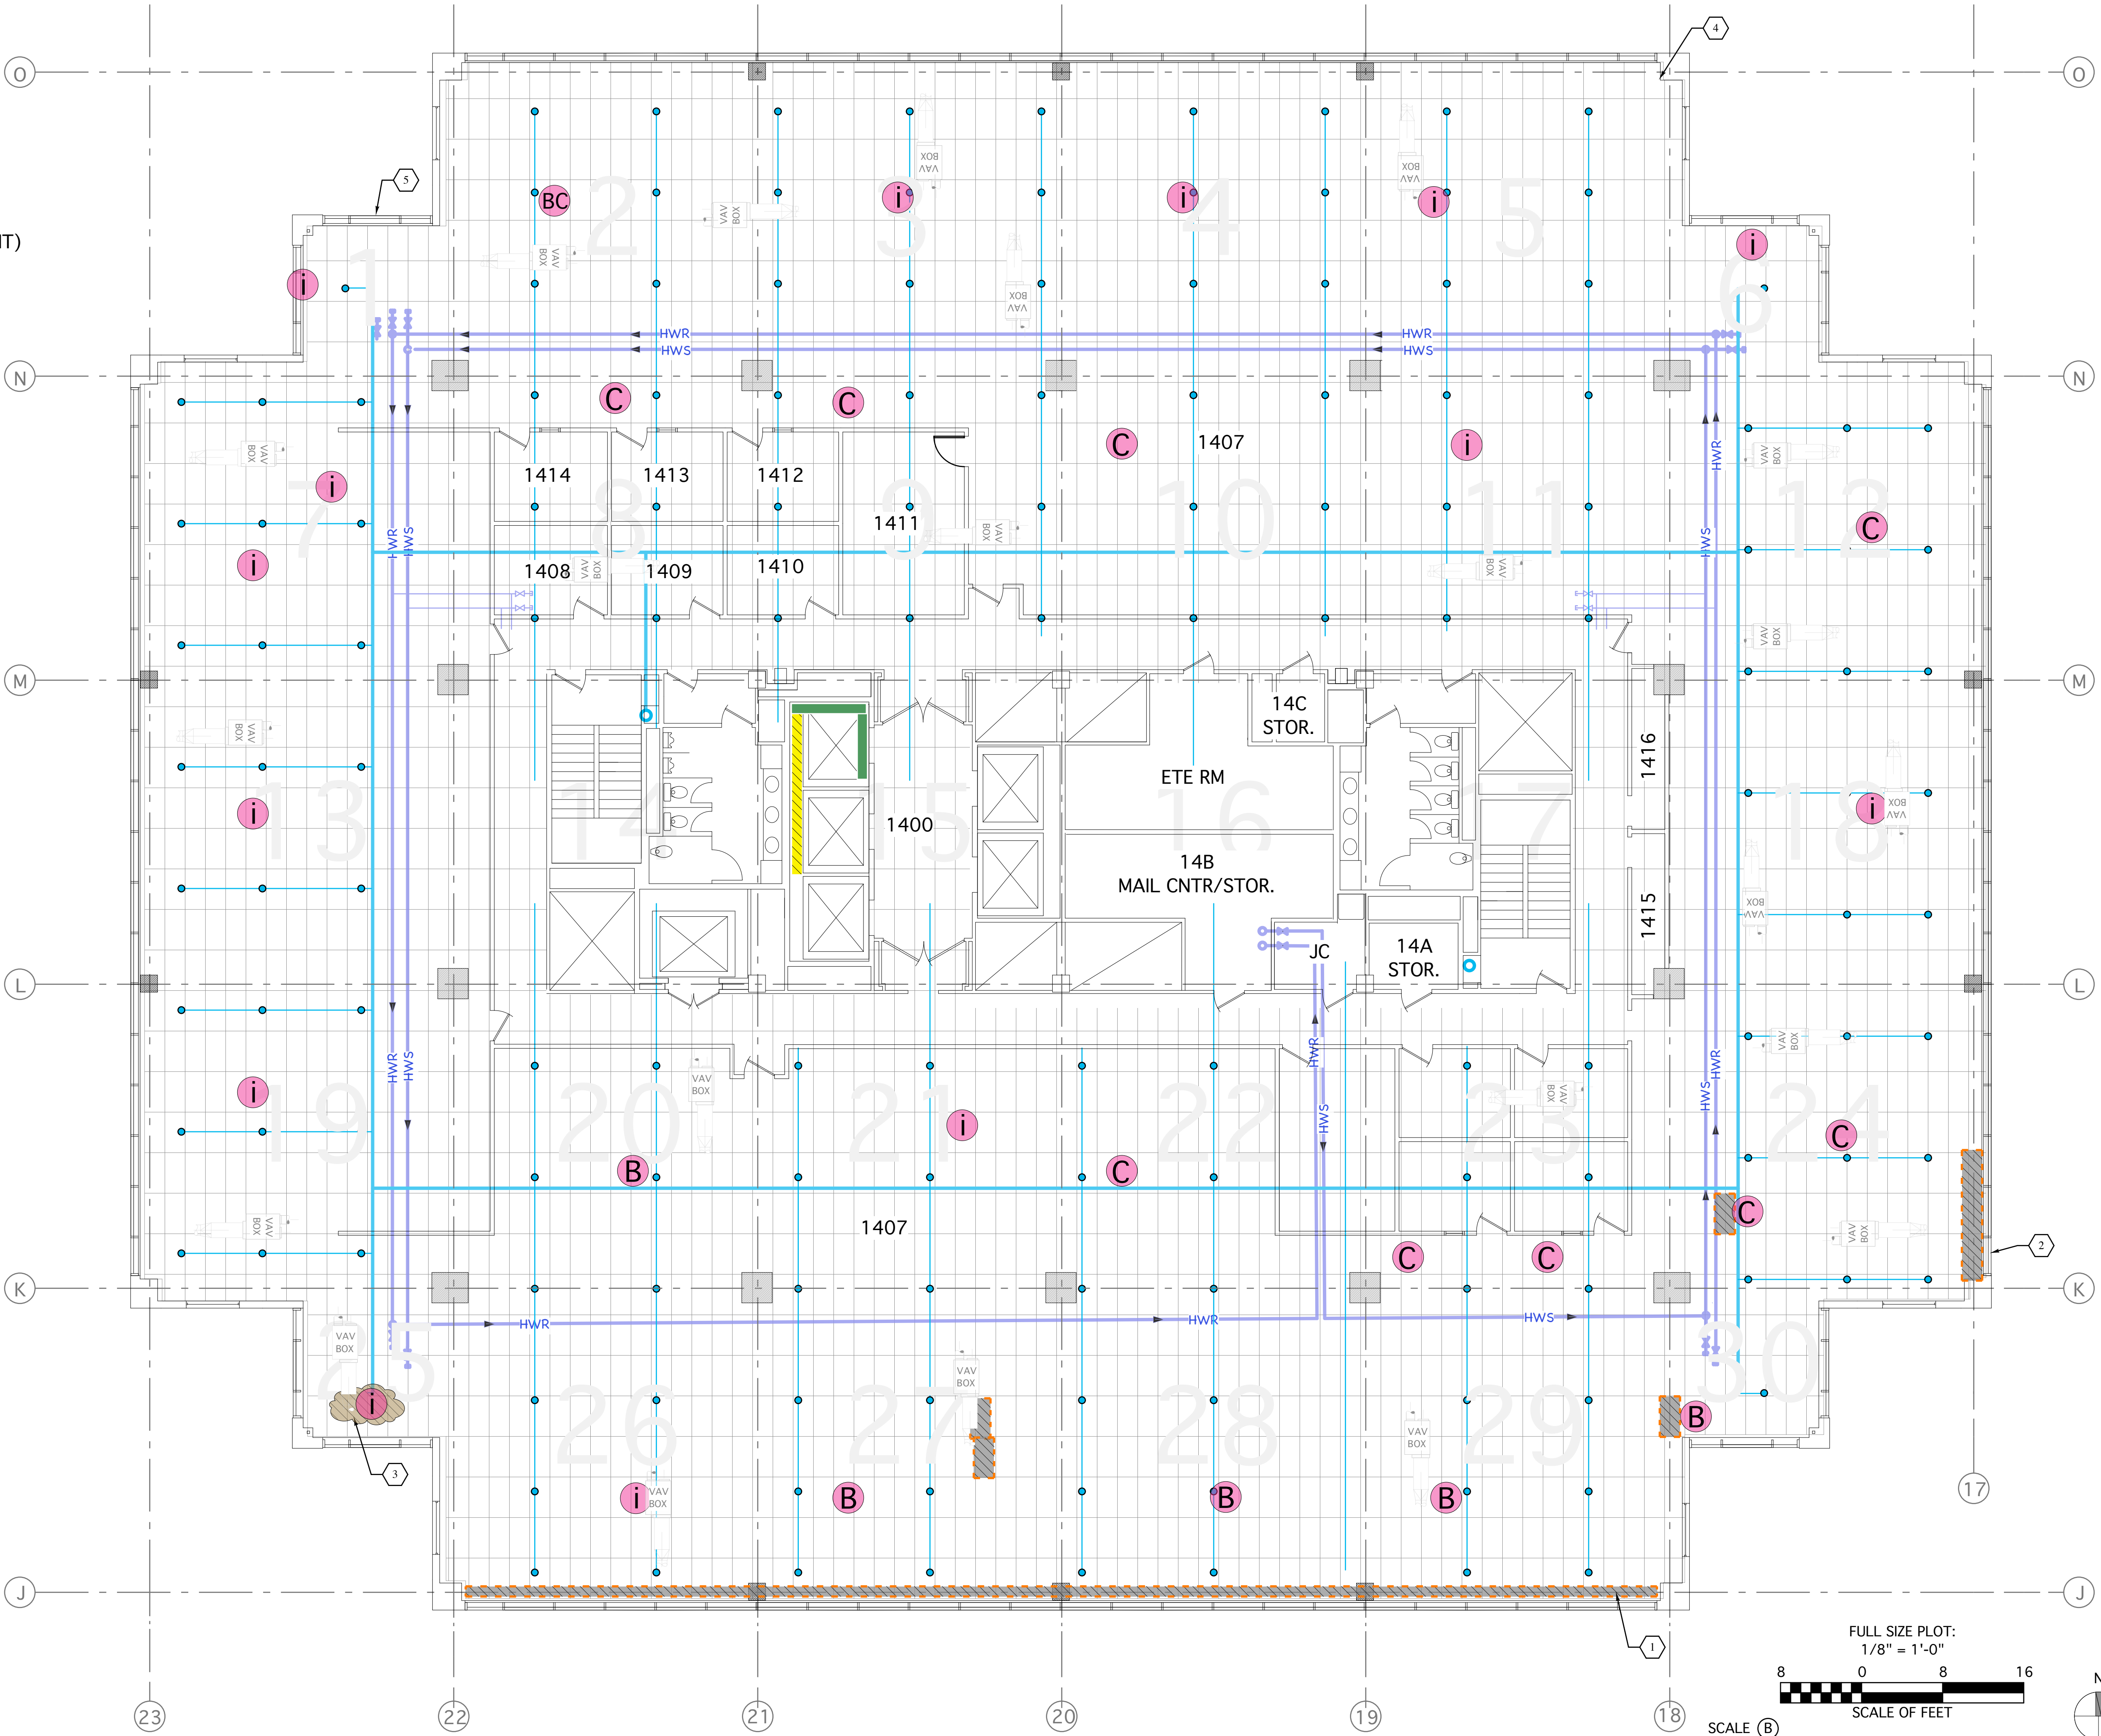
- 1 J LINE WATER LEAKAGE ABOVE WINDOWS
- 2 K/17 CURTAIN WALL LEAK
- 3 K/22 WET CARPET
- 4 N/18 CARPET STAIN (CURRENT)
- 5 WATER DAMAGE ON WINDOW SILL (CURRENT)
- 6
